Monitoring Morphology and Currents at the Hatteras Breach

ABSTRACT

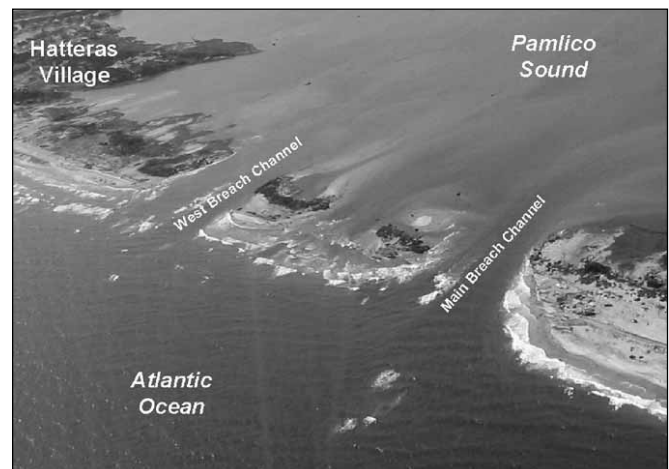
Figure 2. Hatteras breach, 22 September 2003 (USACE Wilmington District photograph).

Wamsley 2003). The Hatteras breach destroyed utility infrastructure and severed North Carolina Highway 12, isolating Hatteras Village from the rest of Hatteras Island. Parking lots and buildings near the breach were also destroyed. Highway 12 is the only transportation route east from the village. Residents were unable to drive to work and home. Businesses at Hatteras Village and on Ocracoke Island experienced loss of tourism revenue because of the restricted access.

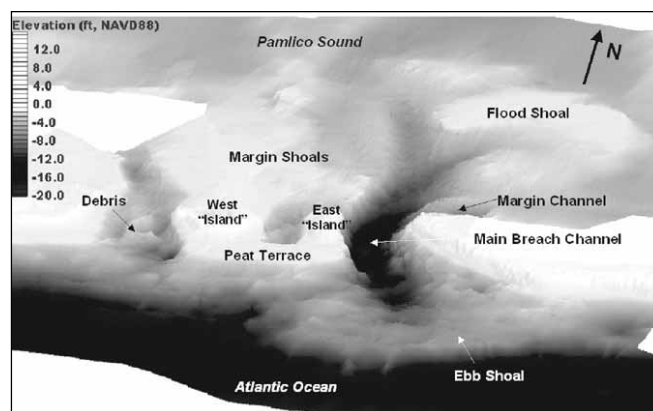
Figure 3. Digital elevation model of Hatteras Breach.

best coverage of the nearshore region just seaward of the breach openings and, combined with the ebb shoal data, provides the most comprehensive data set. Figure 3 is a DEM created for illustrative purposes from Survey 2 data combined with the multi-beam ebb shoal data. Three breach channels, separated by breach islands, are well defined. The breach islands were not washed away because of resistance of peat outcroppings that fronted the islands on the ocean side (Figure 4). The peat acted as an erosion-resistant barrier, revetting the island at this location. The broad peat terrace extended from the eastern most breach island, across the middle breach channel and west breach island (Figure 3).

The flood shoal is readily identifiable in Figure 3. The Survey 1 DEM showed that a flood shoal formed within 2 weeks after the breach opened with the centroid approximately 1,750 ft from Highway 12. The shallowest water over the flood shoal was less than 0.5 ft NAVD88 and had to be surveyed by wading, as depths were too small even for the waverunner system. The second survey showed little growth of the flood shoal. A volumetric analysis indicates that the flood shoal gained on the order of 10,000 cu yd of sand over the 10-day period. A well-defined ebb shoal also formed by 5 October (Figure 3). The ebb shoal extended offshore as far as 1,250 ft from the former location of the highway. Depths over the ebb shoal were 4 to 6 ft NAVD88. Waves were often observed breaking on the ebb shoal.

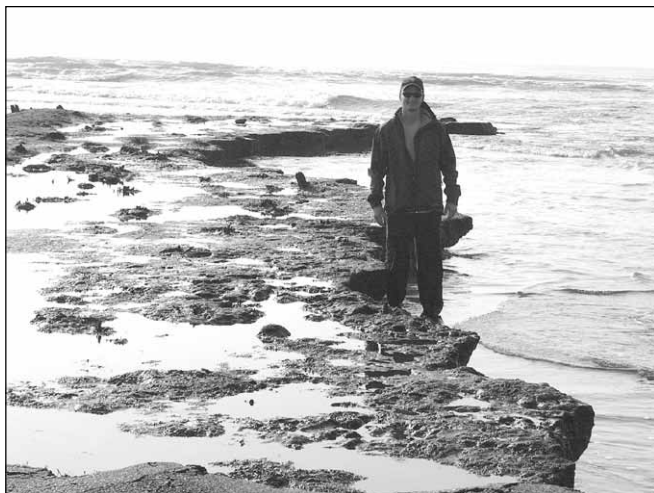
Figure 4. Western edge of peat terrace, looking southeast. The peat extends approximately 1.5 to 2 ft above the adjacent sandy bottom.

The peat terrace restricted flow in the middle breach channel, which was about 225 ft wide. Water flowed through the middle channel and over the peat terrace only at higher tide elevations. The restricted flow resulted in little scour of this channel. Maximum depths in the middle channel were about 5 ft NAVD88 (1988 North American Vertical Datum). The west channel was about 350 ft wide and littered with debris (Figure 5). Pilings from the bridge partially constructed in the 1930s extended across the channel on the ocean side. Large chunks of asphalt and roadbed material were visible at lower tide elevations, particularly on the west side of the channel. Near the center of the channel was a peat outcropping with large chunks of asphalt resting on top. The flow through the west channel was somewhat greater than that of the middle channel. Survey 2 maximum

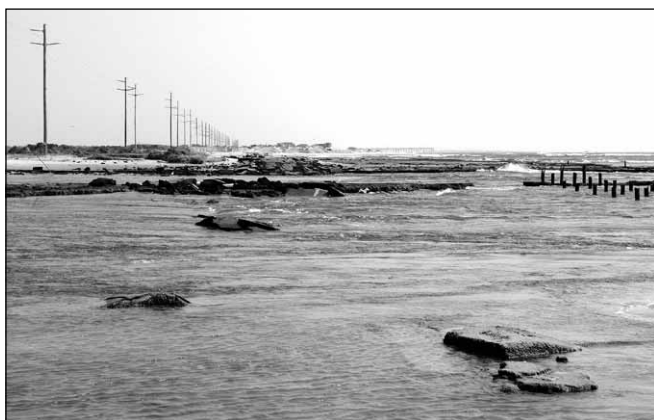
Figure 5. West breach channel, looking east, 5 October 2003. Note the old bridge pilings on the right and the extensive road debris in the channel.

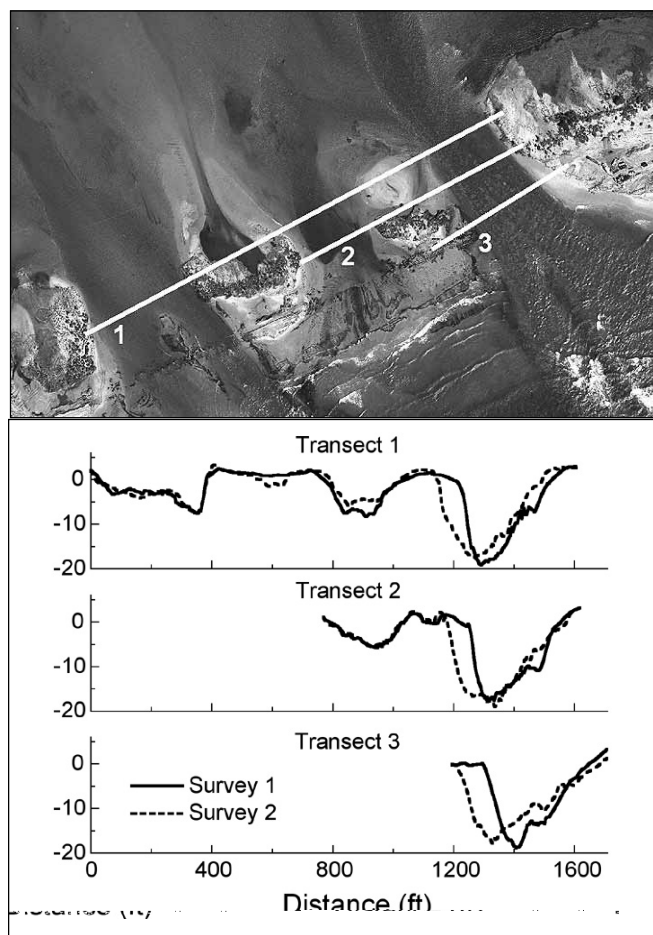
The DEM analysis indicates rapid morphology change. Figure 6 is a comparison plot of breach cross-sections from Surveys 1 and 2. Comparisons are made only where sufficient coverage of the channel was captured by both surveys. Due to debris and wave conditions, the seaward end of the west breach channel was not measured in Survey 1. As Figure 6 shows, there was little change in the west channel, because of the substantial amount of armoring by debris and peat. Flow velocities were significantly weaker than observed in the main channel. The sound end of the

Figure 6. Comparison of Survey 1 and Survey 2 breach channel cross-sections (North Carolina Department of Transportation (NCDOT) photograph).

middle channel shoaled approximately 2.5 ft in the 10 days between surveys. The sediment likely originated at the margin shoals on the sound side and could not be flushed out by flow restricted by the peat terrace. The central and seaward portions of the middle channel did not change between Surveys 1 and 2.

The main breach channel experienced the greatest amount of change. Defining breach width as the distance across the channel between the NAVD88 0-contour (which corresponds to +0.44 ft msl), the breach widened by approximately 125 ft on the ocean side, 65 ft through the middle part of the channel, and 25 ft on the sound side. From the center of the barrier toward the sound, the main channel migrated approximately 20 ft to the west over the 10-day period while on the ocean side the channel migrated over 80 ft to the west. The average channel depths were maintained and maximum channel depths generally increased through the middle part of the channel and decreased on the sound side over the 10-day period. The average cross-sectional area of the breach channel increased from 3,400 to 4,000 sq ft.

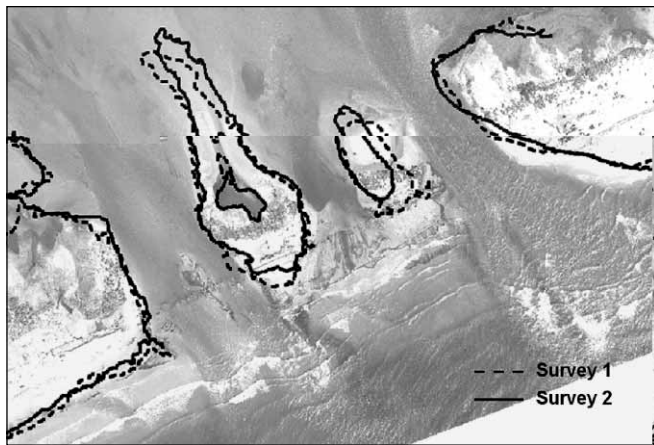
Figure 7. Comparison of the 0-contour (NAVD88). The aerial photograph was taken on 24 September, tide elevation -1.3 ft NAVD88 (NCDOT photograph).

Figure 7 is a comparison of the 0-contour (NAVD88) between Surveys 1 and 2. The recession of both channel banks at the ocean end of the breach is evident. The east bank receded 25 to 45 ft while the west bank moved 40 to 80 ft. On the sound end of the breach channel, the east bank advanced approximately 25 ft, pushing the channel to the west. This end of the channel also continued to widen, however, as the west bank receded about 45 ft.

The prograding shoulder of the barrier island was supplied sediment from the ocean end of the breach bank and the sound side of the barrier island. A strong current was observed in the margin channel on the east side of the breach. Bank erosion was easily observed at this location. As the tide fell, a scarp formed on the sound side of the barrier. During lower tide elevations, the strong flow removed sand from the base of the scarp until a tension crack formed, leading to mass failure. The sandy bank material slumped into the margin channel, moving down the bank slope where the tidal current carried it downstream. At higher tide elevations, the scarp became submerged and was smoothed by the current flow and wave action. Recession of the 0-contour as a result of this process is seen in Figure 7. The maximum shoreline recession measured over the 10-day period at the margin channel was approximately 20 ft.

Figure 7 illustrates the elongation of the margin shoals behind both breach islands. The east island shoal advanced approximately 65 ft. The west island shoal migrated in a

northerly direction and also elongated by approximately 65 ft. The 0-contour on the front side of each island receded. This recession, however, was not from erosion of the peat terrace. The peat terrace elevation was below 0 NAVD88, and the sandy material on top eroded during higher tide elevations.

Figure 7 also shows beach shoreline change within about 500 ft of the breach. On the west side, the beach eroded approximately 35 ft. Sediment supplied by longshore transport advanced the shoreline to the east by as much as 55 ft within about 425 ft of the breach channel. The beach tended toward erosion at greater distances from the breach.

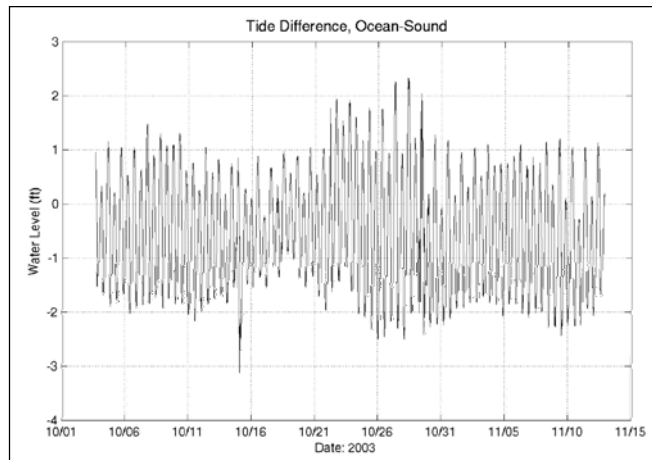
Figure 8. Pamlico Sound and ocean water level difference, 3 October to 12 November 2003.

The measured water level (head) difference between the ocean and sound are plotted in Figure 8. Water level head differences exceeding 2.3 ft were observed on both flood and ebb currents. Water levels for the pier, sound, and the head difference from 14-18 October are plotted in Figure 9 along with wind measurements from the Hatteras Weather Service (Mitchell Field, 2.5 miles east of the breach). Wind contributes to head difference, particularly in determining sound water levels. Pamlico Sound, having a large surface area and shallow water, can experience large wind-driven setup. On 15 October, the wind switched from having a west component to an easterly component, resulting in setup in the sound and a large negative head (ocean levels lower than the sound) of -3.1 ft. There was a gap in the wind data on 15 and 16 October, but based on measurements at the FRF (66 miles north of the breach), the

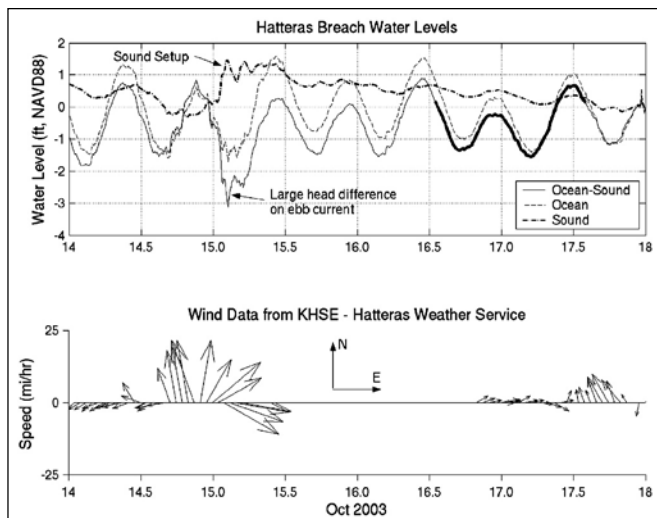
Figure 9. Ocean and sound water levels, head difference, and wind vectors. Bold line indicated times when bottom mounted ADCP was operational.

wind continued to be directed toward the east and south, favorable for setup in the southeast corner of the Pamlico Sound near the breach. As a result, a nearly continuous ebb current flowed for approximately 32 hours.

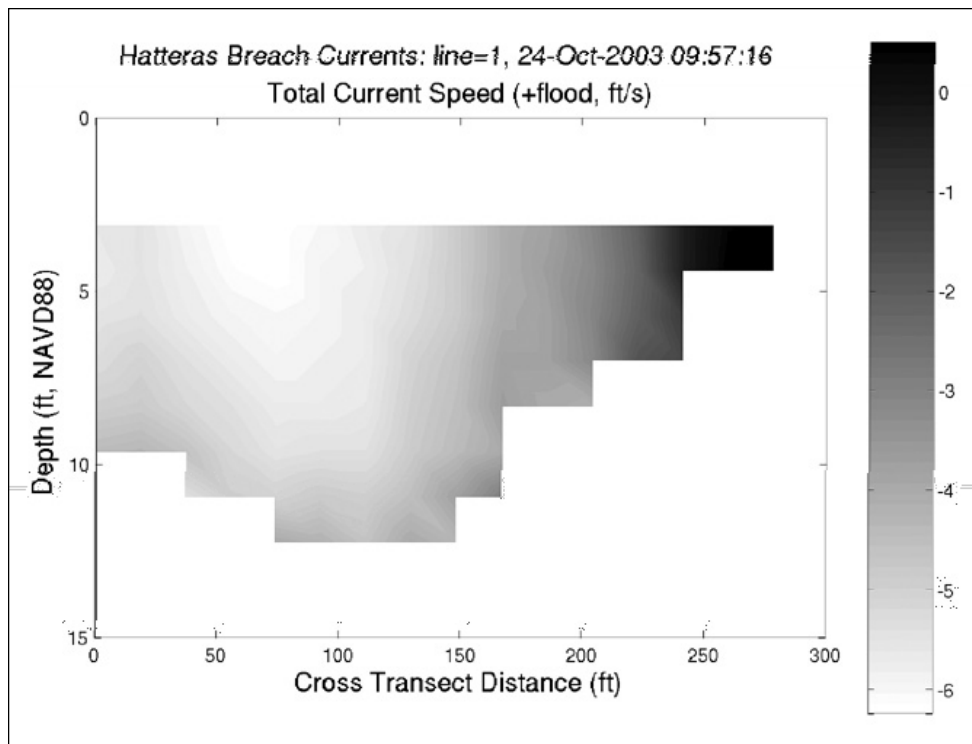
An example of an averaged ADCP ebb current transect is shown in Figure 11 for Line 1 on 16 October. Strongest currents

Figure 11. Example ADCP current transect at line 1.

are to the west (left) of the channel center. Ebb current transects for Line 2 indicate that the strongest currents tend towards the channel center. On Line 3, the strongest currents are observed to be east of the channel center and sometimes have two distinct maxima, one that parallels the main channel and another from the margin channel on the northeast side of the breach. This preliminary analysis of ADCP transect data corresponds to visual observations of surface currents, namely, that on ebb flow two distinct currents merged at the breach, and on flood flow there was a strong current through the main channel with a more diffuse current spread out over the area between the flood shoal and margin channel.
